British Tug Association Safety Seminar – A Legal Perspective

Presented by Simon Tatham

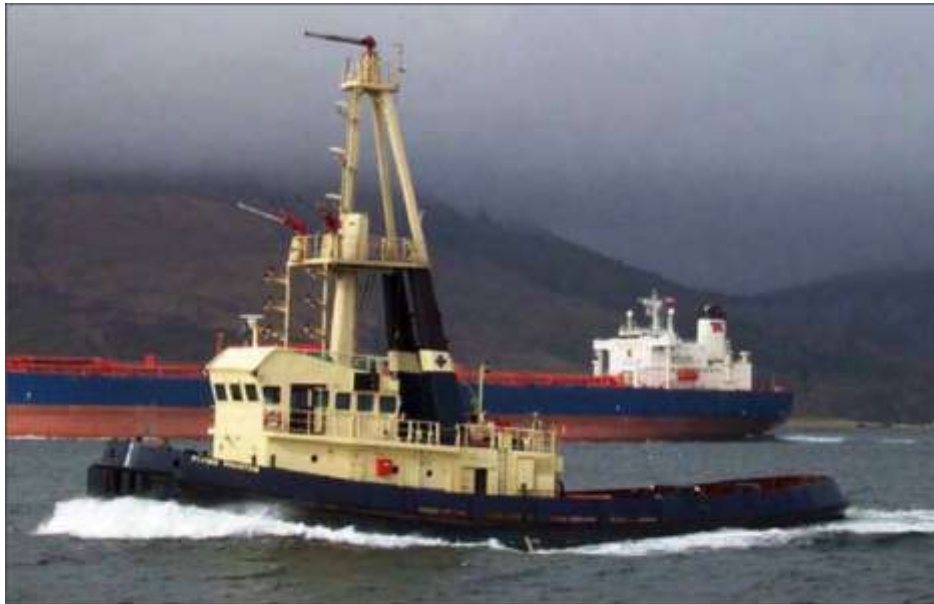
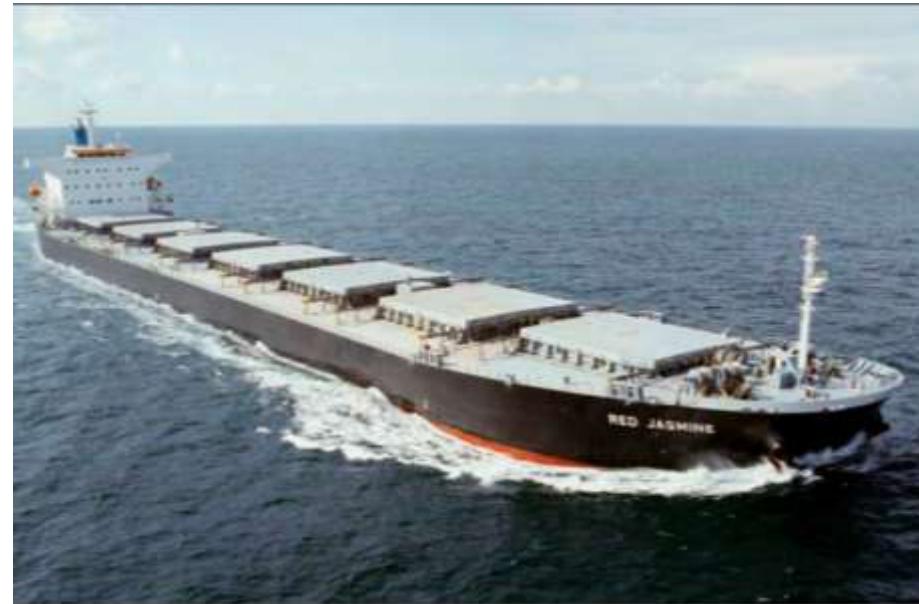
Flying Phantom - 2007

Incident Clyde, in fog

- Acting as a bow tug to assist bulk carrier *Red Jasmine*
- Three of four crew were killed

- Emergency release system was too slow
- No operational procedures for tug operation in fog

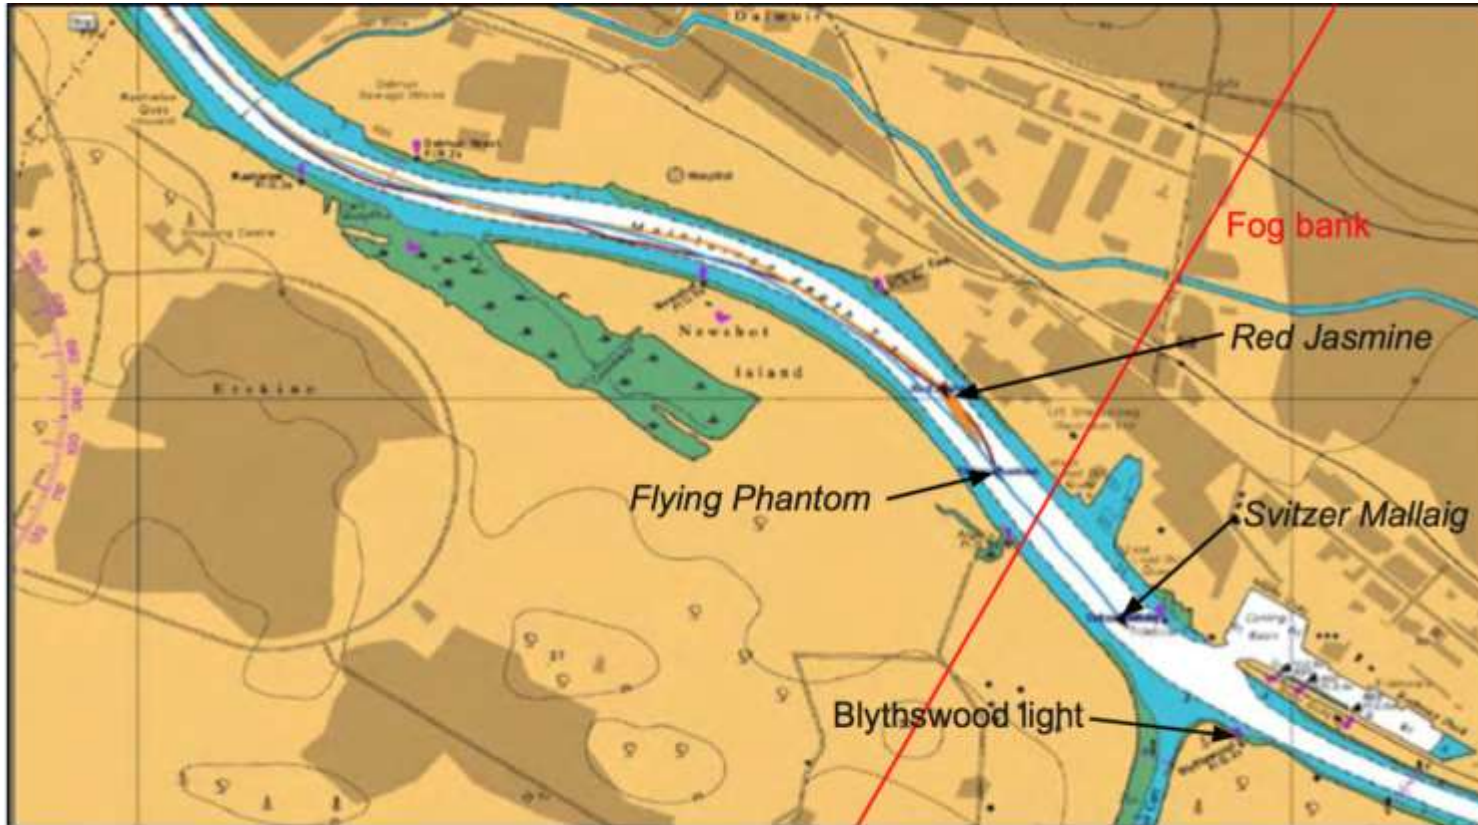
Vessel tracks and estimation of fog bank

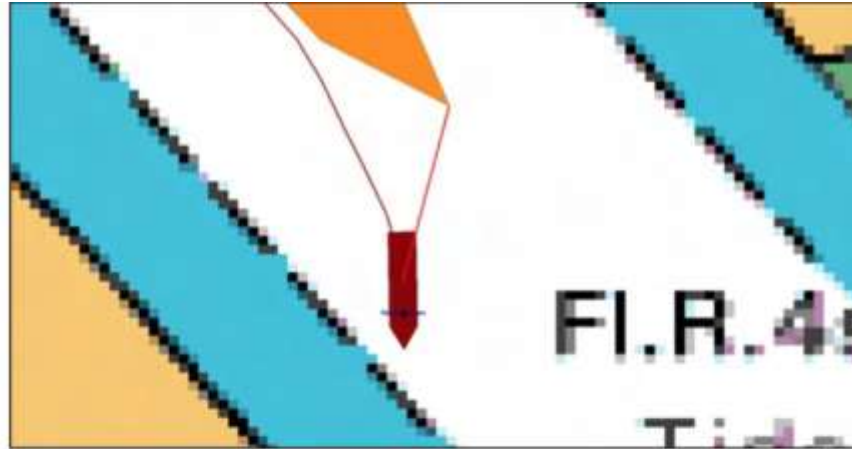
17:59.02 - Pilot instructs *Flying Phantom* to ease off

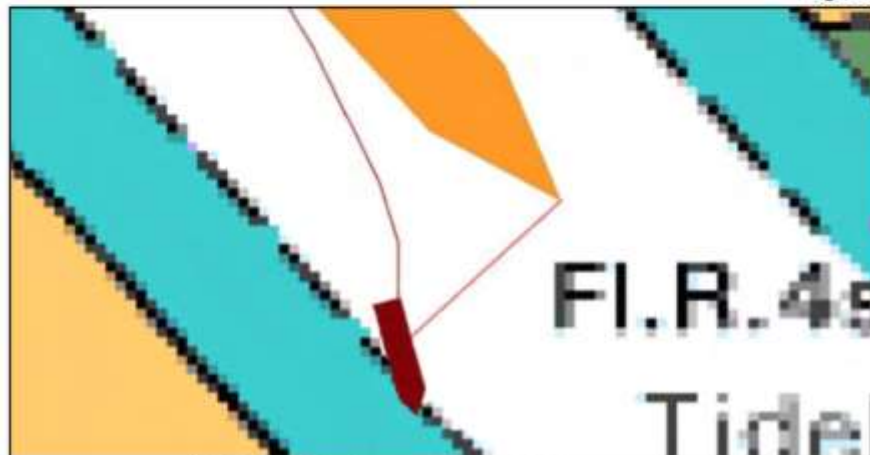
Figure 8

17:59.20 - *Flying Phantom* informs pilot they are aground

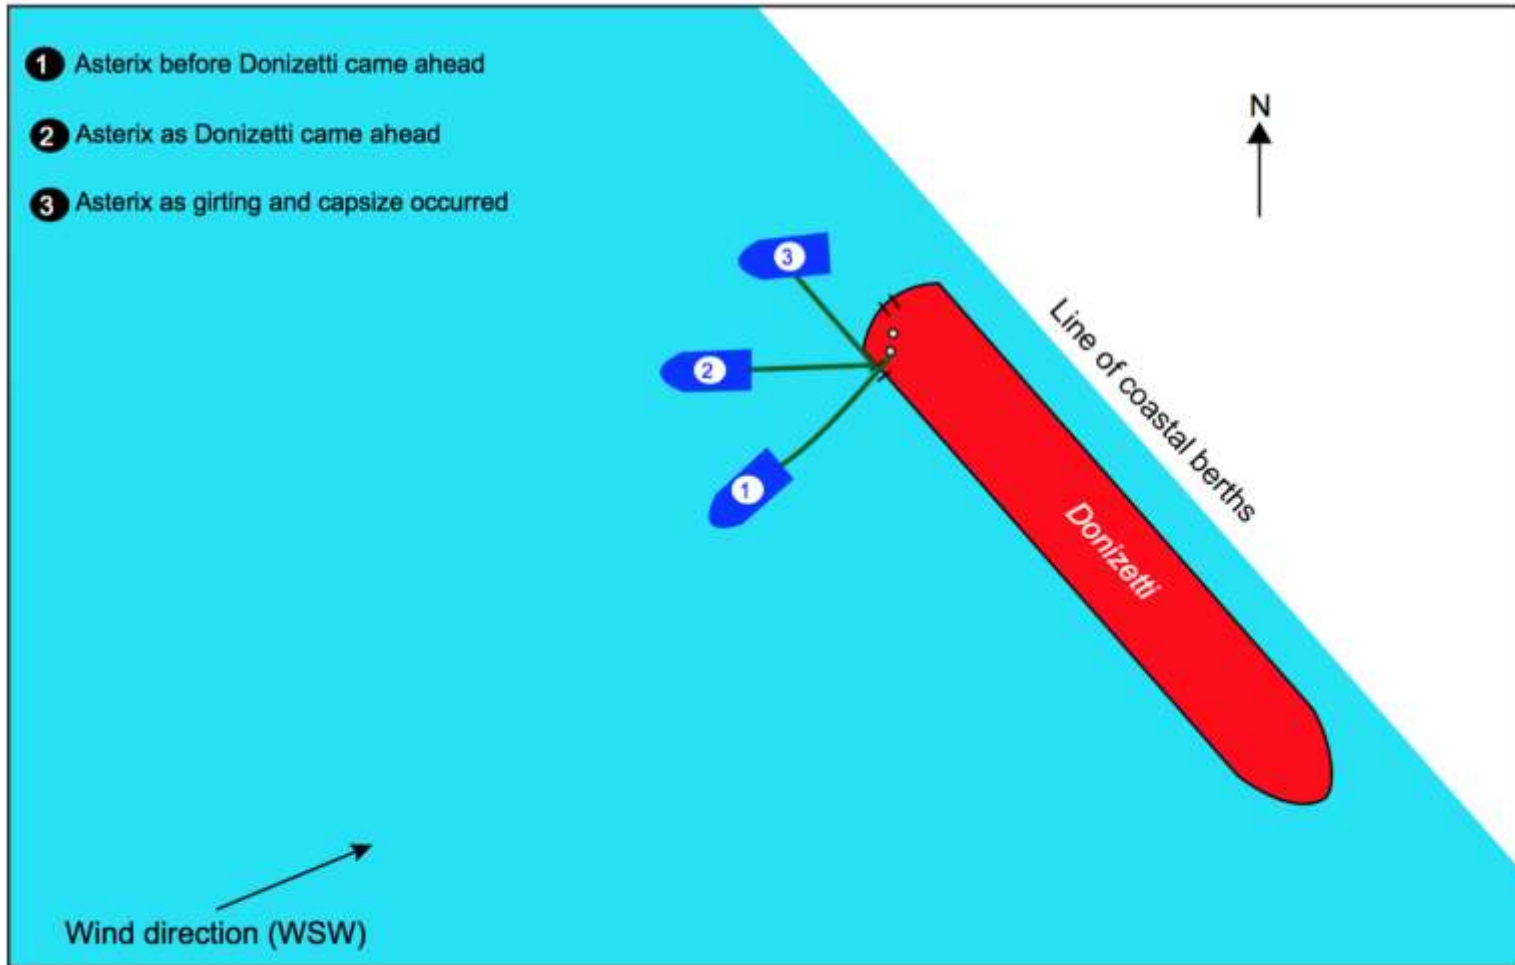
Figure 2: Indicative relative movement of Asterix

- Mooring launch
- Capsized whilst assisting a departing tanker in windy conditions

- Adjustable gog rope was not at optimal length
- Emergency towing hook release was unsuccessful
- Lack of training and drills
