British Tug Association Safety Seminar – A Legal Perspective

Presented by Simon Tatham

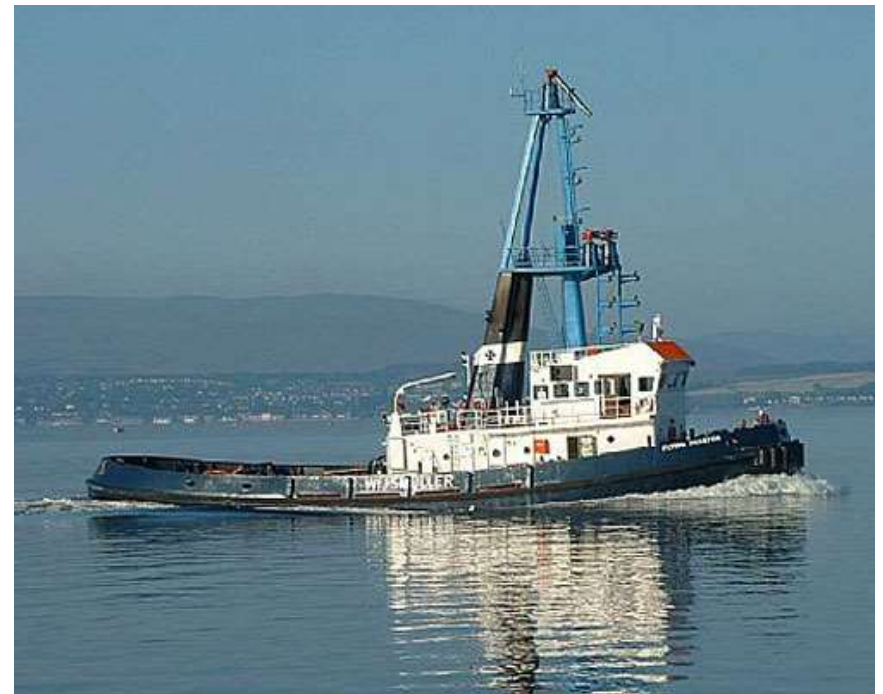
Incident Clyde, in fog

- Acting as a bow tug to assist bulk carrier *Red Jasmine*
- Three of four crew were killed

Criticism of tug

- Emergency release system was too slow
- No operational procedures for tug operation in fog

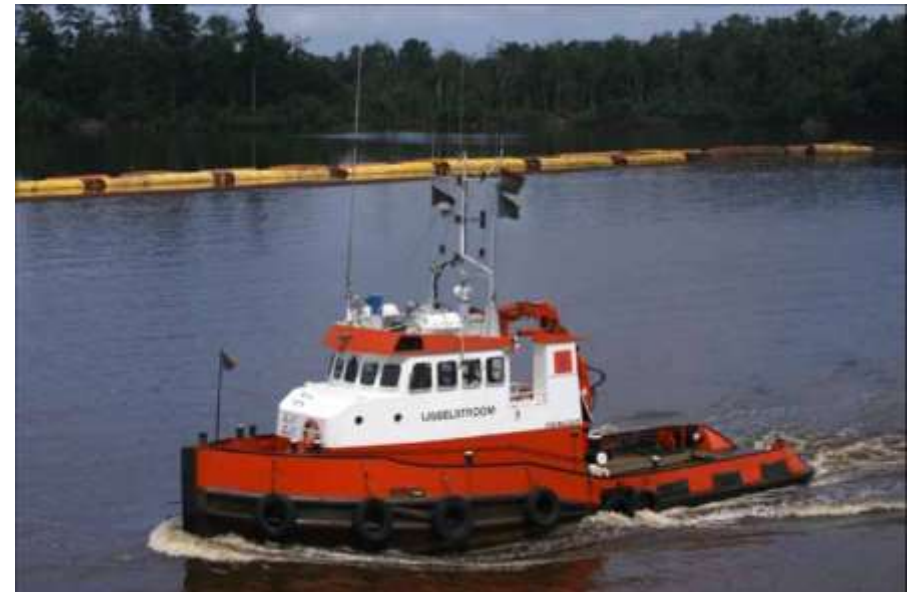
Incident Peterhead

- Acting as a stern tug to a barge
- Lead tug's speed increased
- Tug master was unable to control tug's yawing motion

Criticism of tug

- Connecting without a gog rope
- Failure to understand or operate towline's emergency release

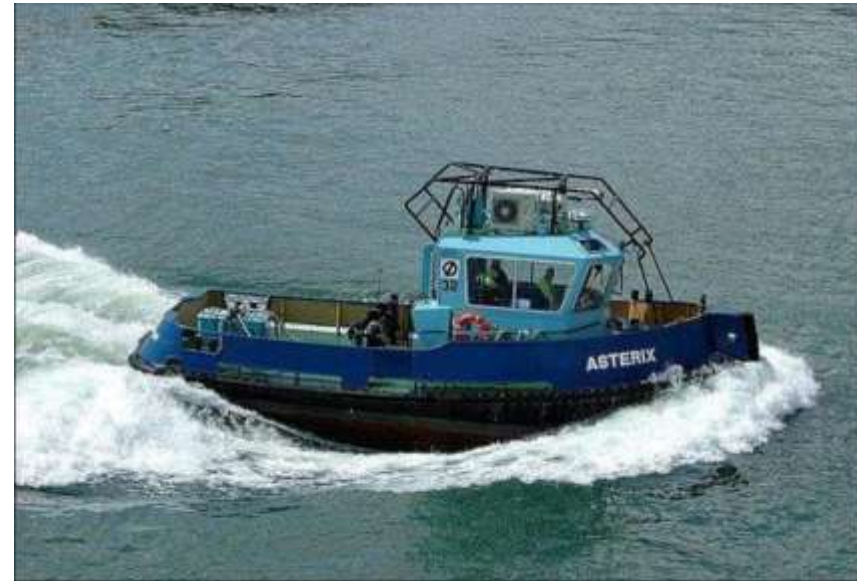
Incident Fawley

- Mooring launch
- Capsized whilst assisting a departing tanker in windy conditions

Criticism of tug

- Adjustable gog rope was not at optimal length
- Emergency towing hook release was unsuccessful
- Lack of training and drills

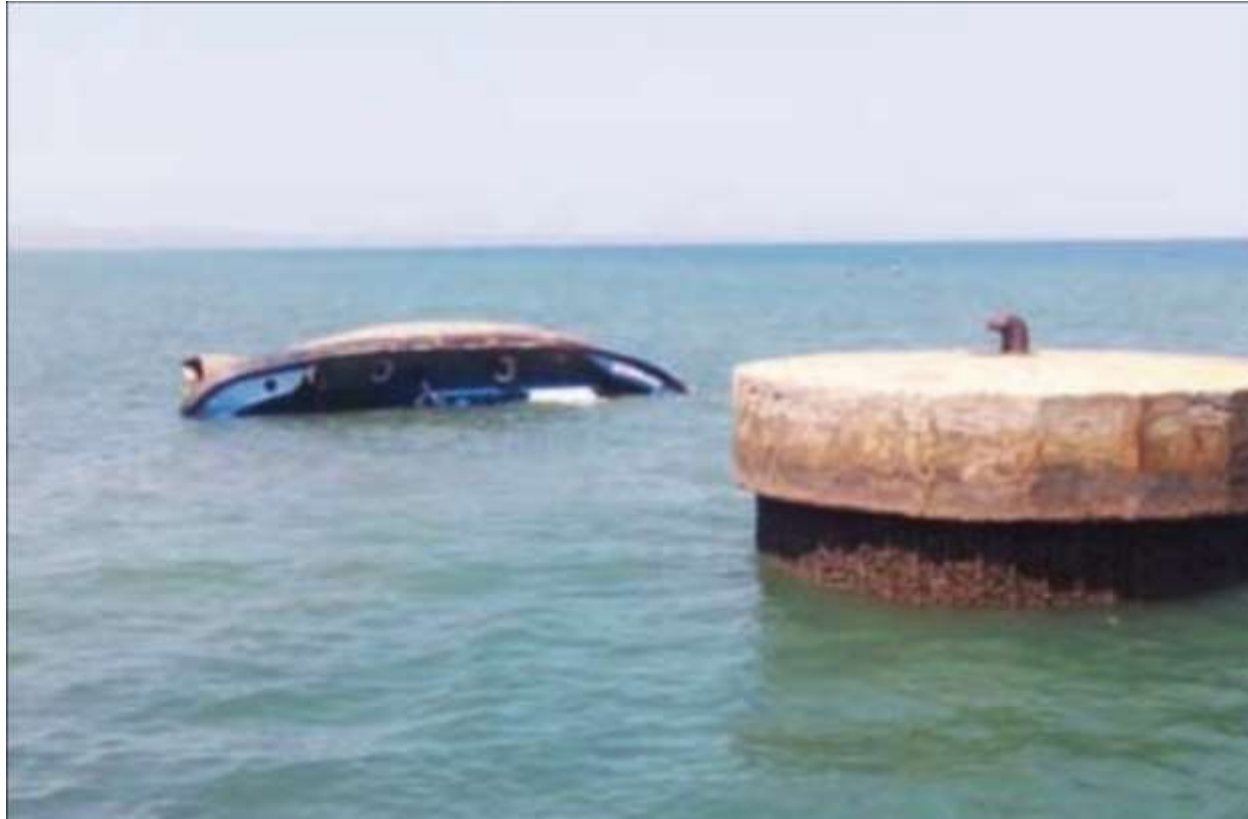
Incident Madagascar

- Tide took the departing vessel down onto a mooring dolphin
- Vessel then manoeuvred ahead to avoid contact
- Tug was unable to counter movements of vessel, and girted

Criticism of tug

- Not being fitted with a gog rope
- No emergency quick release, and doors/hatches open
- Crew inexperienced
